Mendocino Coast **District Hospital**

SPC/NPC Overview Presentation | 05.05.2023

Devenney GROUP

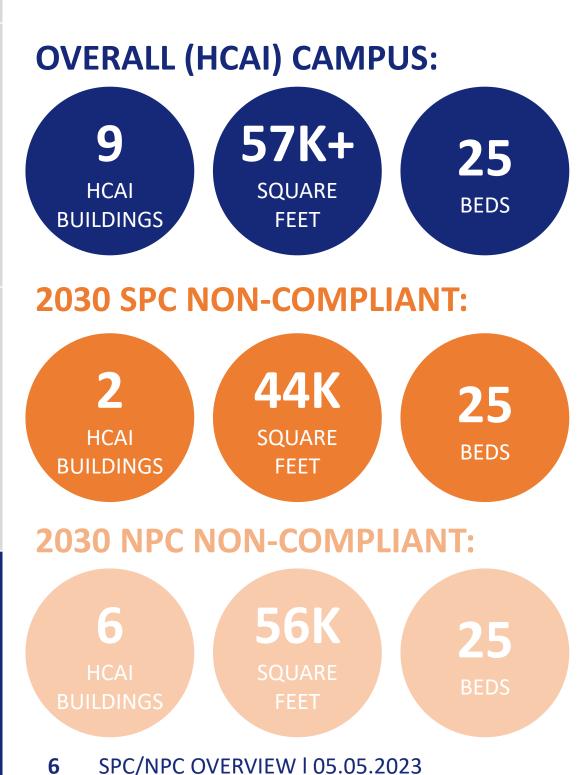
Overview | SPC/NPC Site Plan

SPC/NPC BUILDING LEGEND

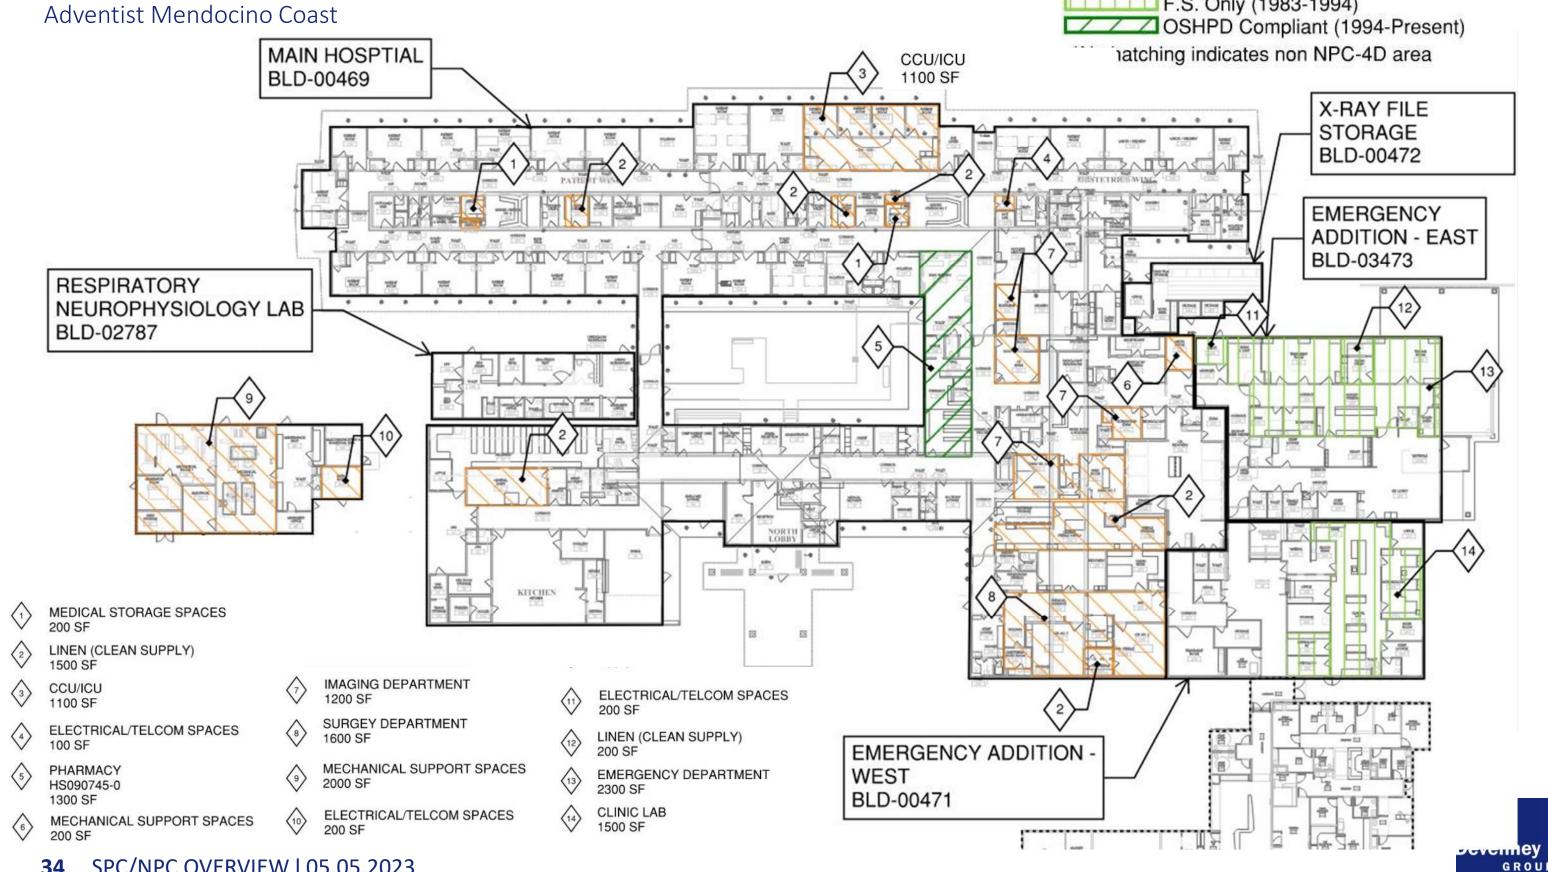
NPC | Scoping Study

LEGEND:

PRE-1973 OSA (1973-1983) F.S. Only (1983-1994)
